Map 5.5-1
Portland Harbor RI/FS
Remedial Investigation Report
Transition Zone Water Chemistry
Total DDX ($\mu\text{g/L}$)
River Mile 6.8 to 7.8

Portland Harbor RI/FS
Remedial Investigation Report
Transition Zone Water Chemistry
Total PAHs ($\mu\text{g/L}$)
River Mile 04 to 05

**Portland Harbor RI/FS
Remedial Investigation Report
Transition Zone Water Chemistry
Total PAHs (μ g/L)
River Mile 05 to 06**

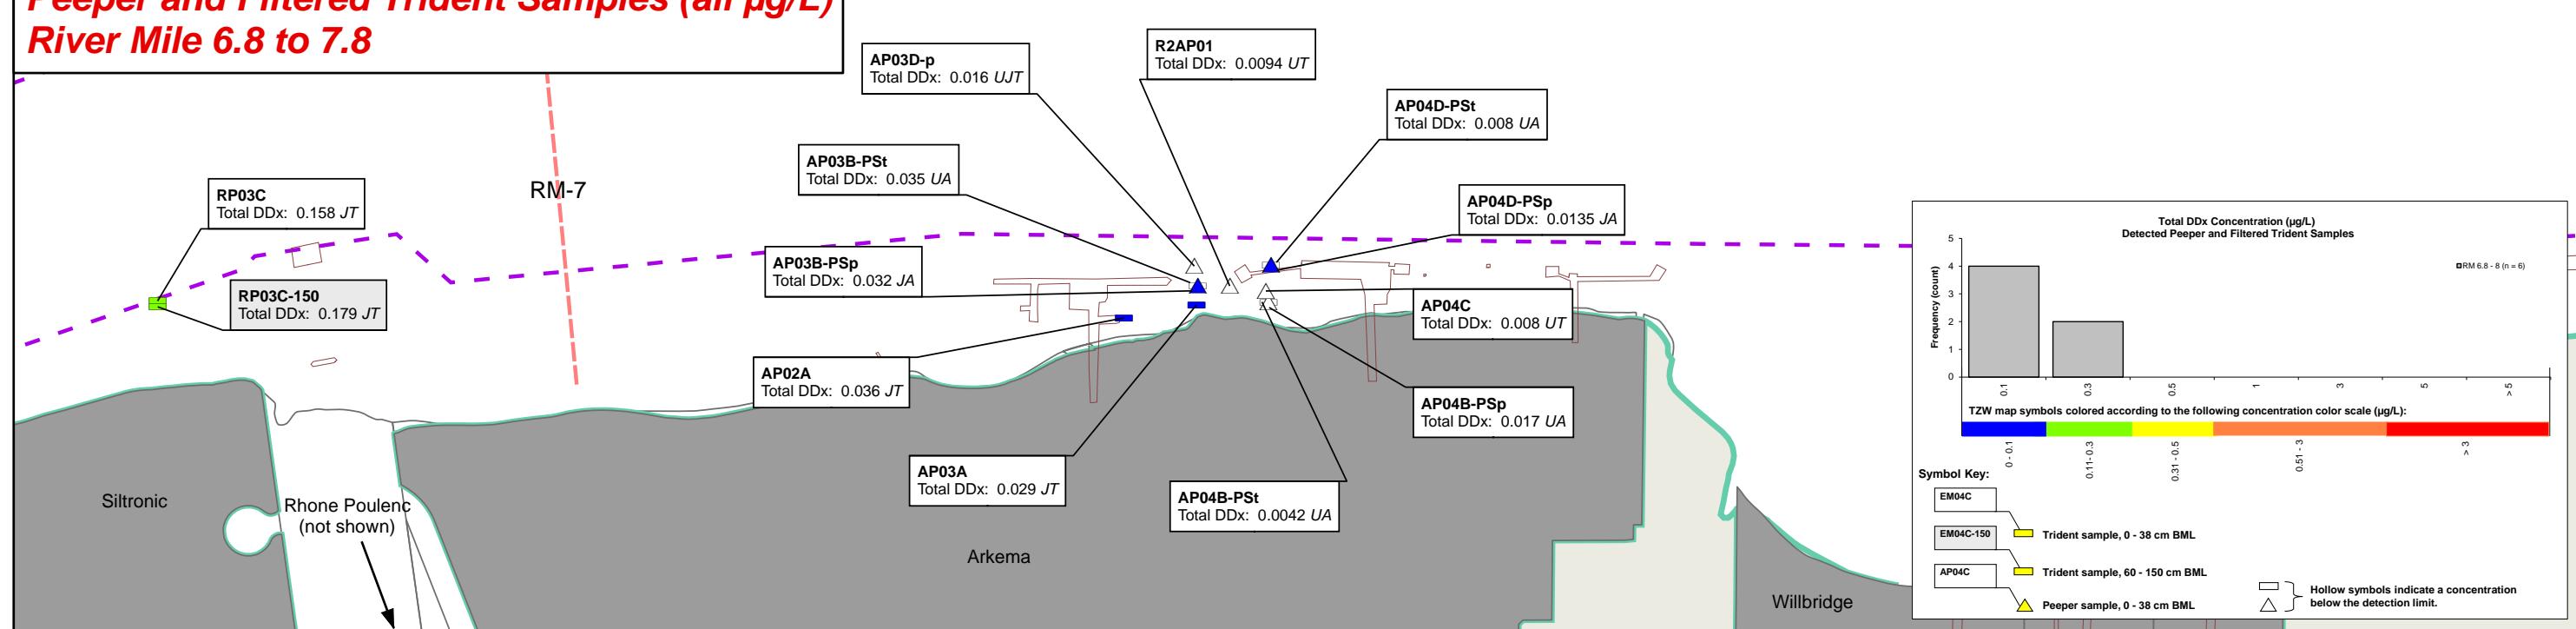
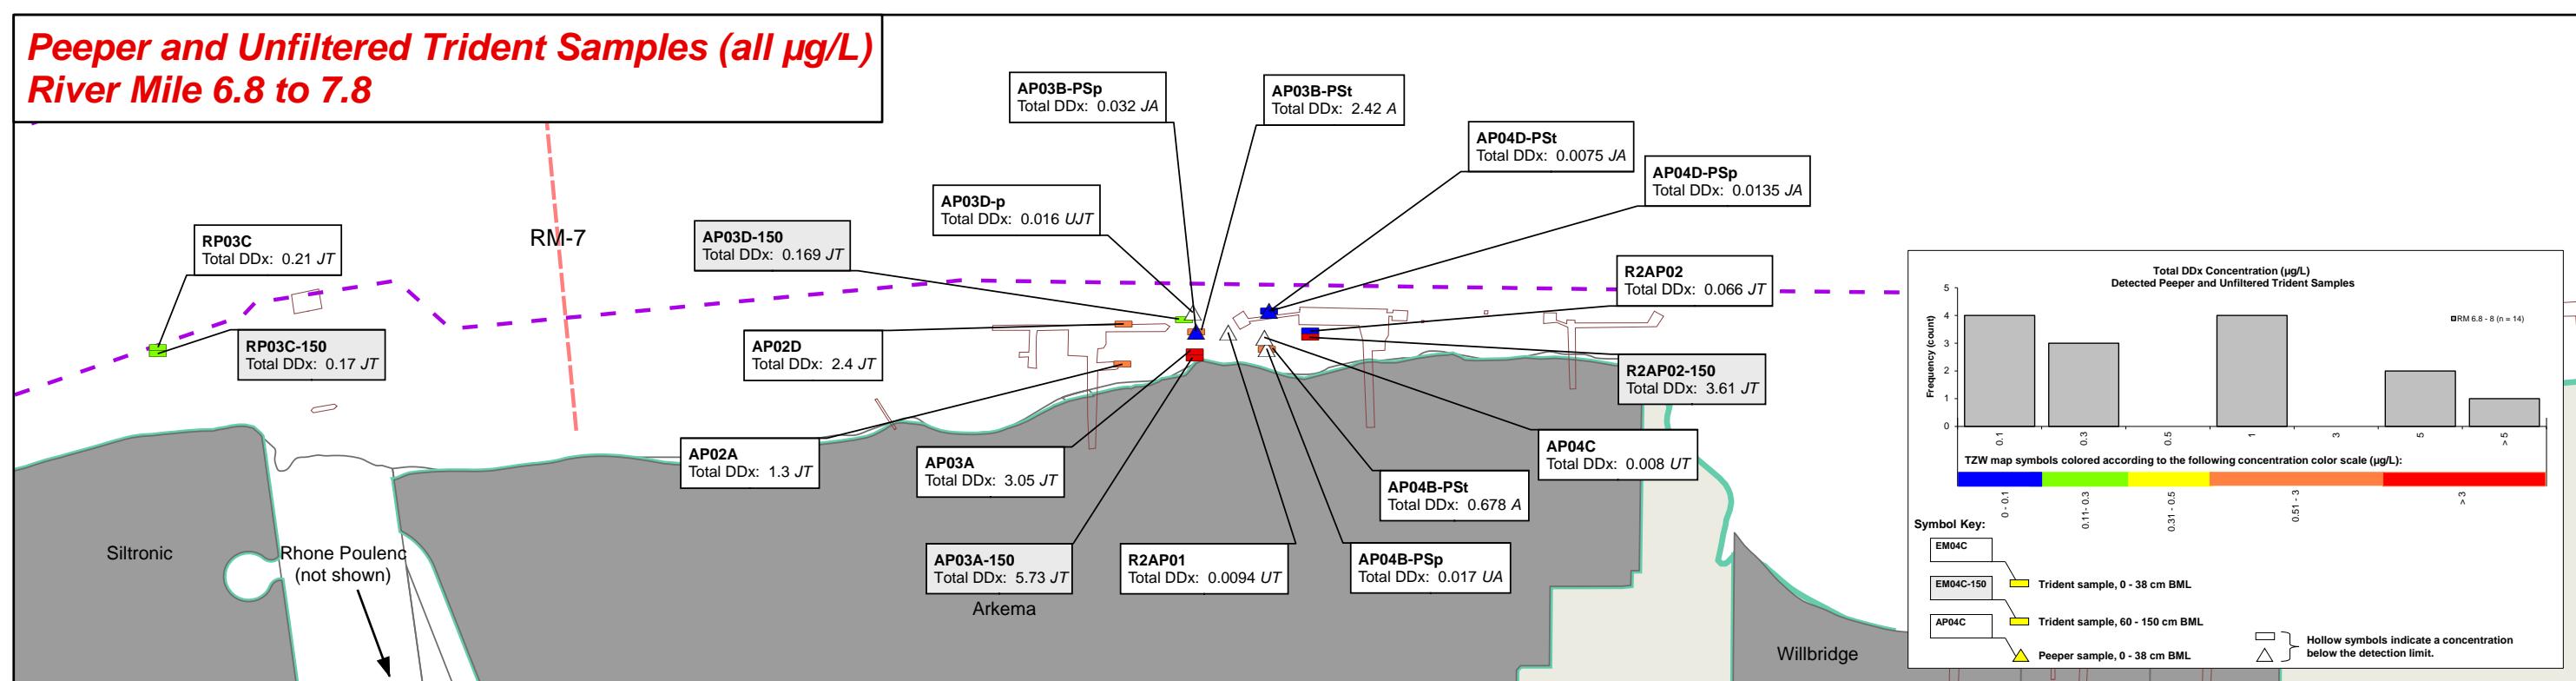
**Peeper and Filtered Trident Samples (all $\mu\text{g/L}$)
River Mile 6.8 to 7.8**

**Peeper and Unfiltered Trident Samples (all $\mu\text{g/L}$)
River Mile 6.8 to 7.8**

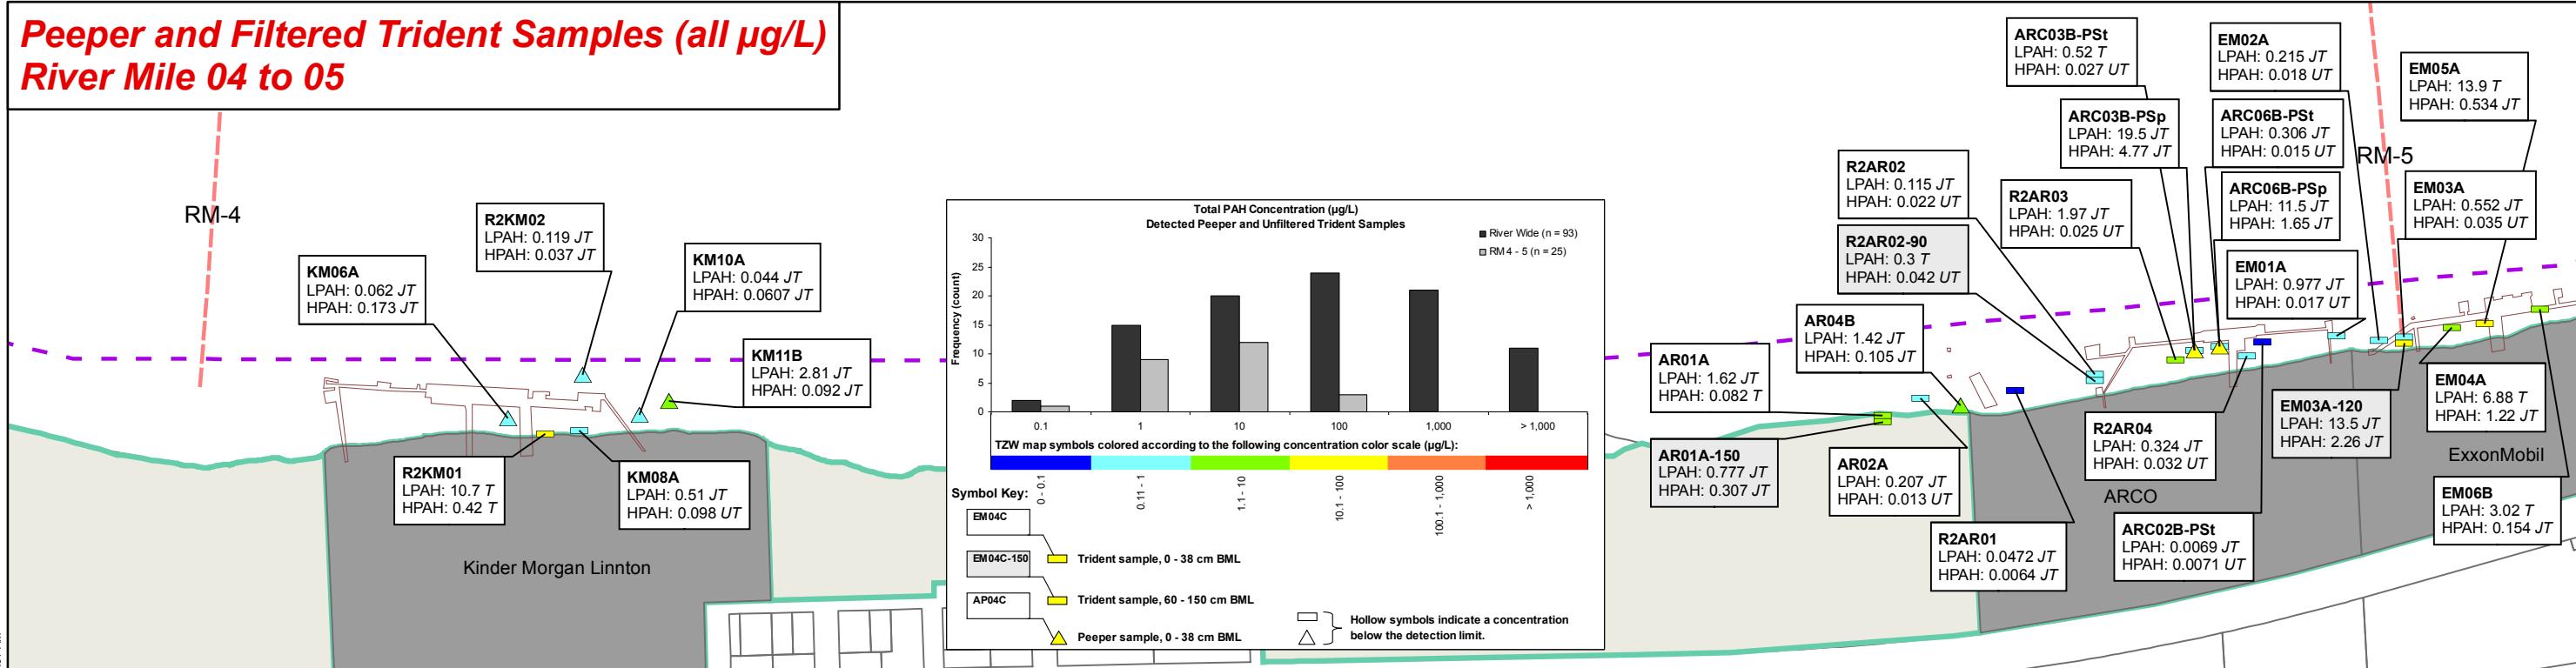
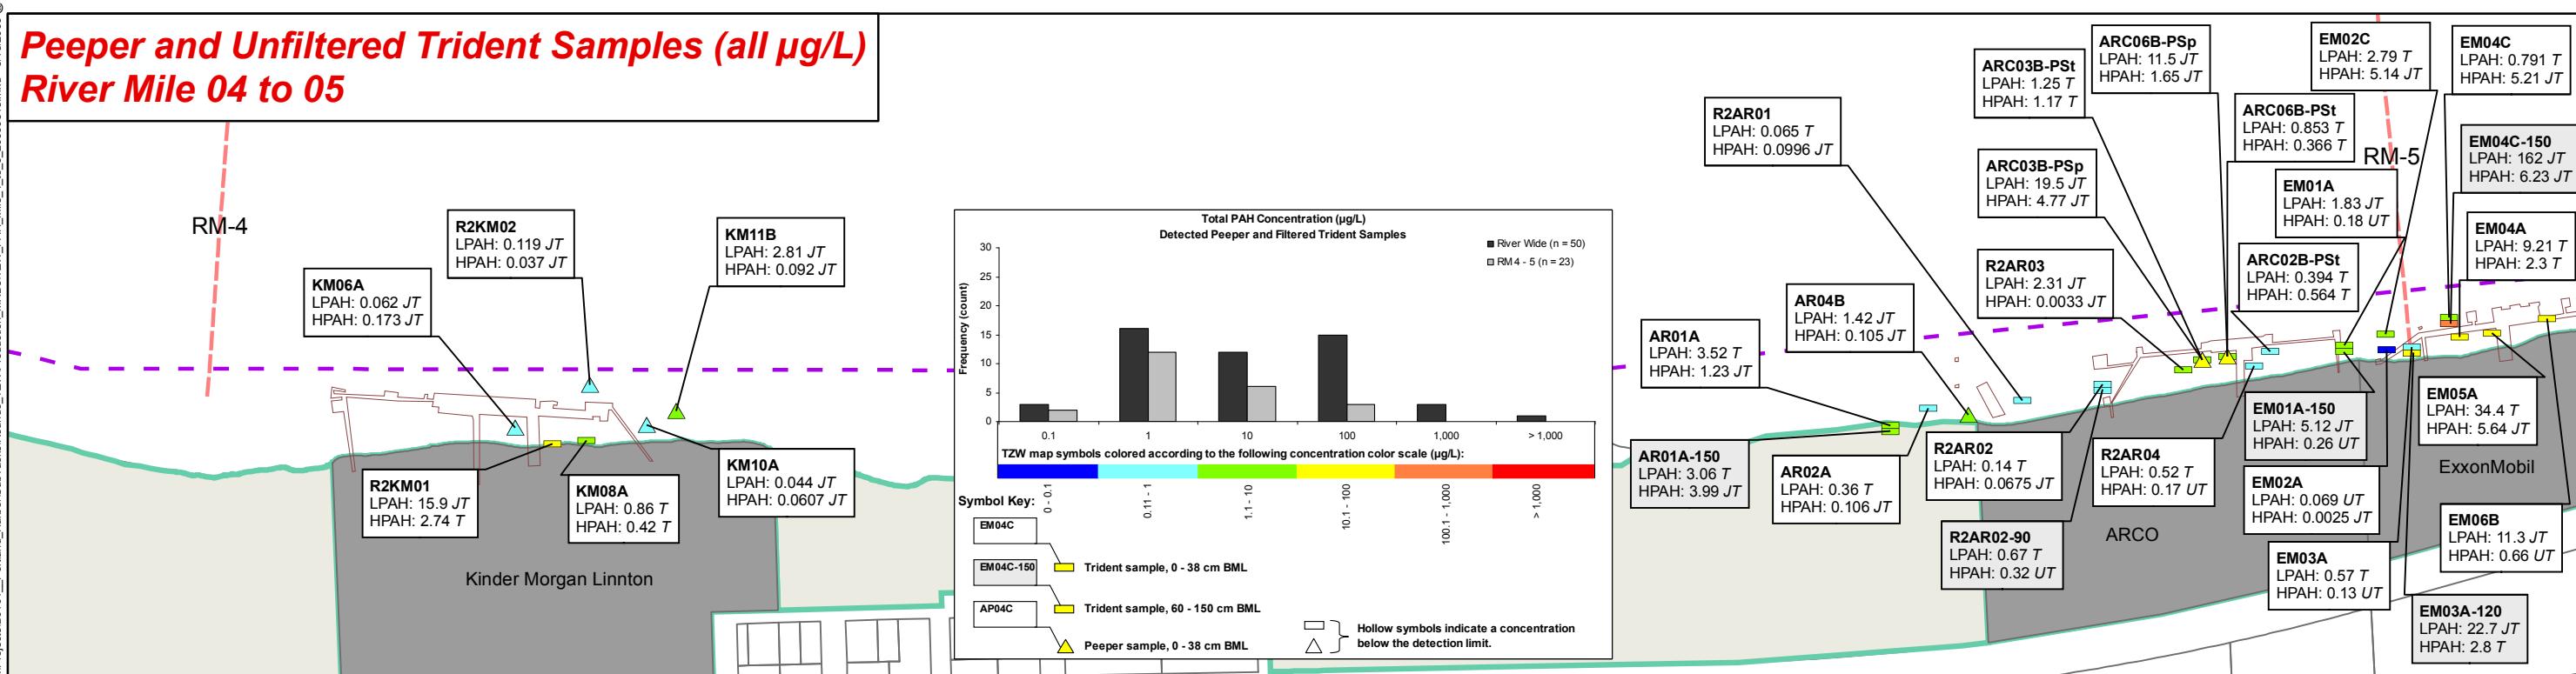
Map 5.5-2a

**Peeper and Filtered Trident Samples (all $\mu\text{g/L}$)
River Mile 04 to 05**

**Peeper and Unfiltered Trident Samples (all $\mu\text{g/L}$)
River Mile 04 to 05**

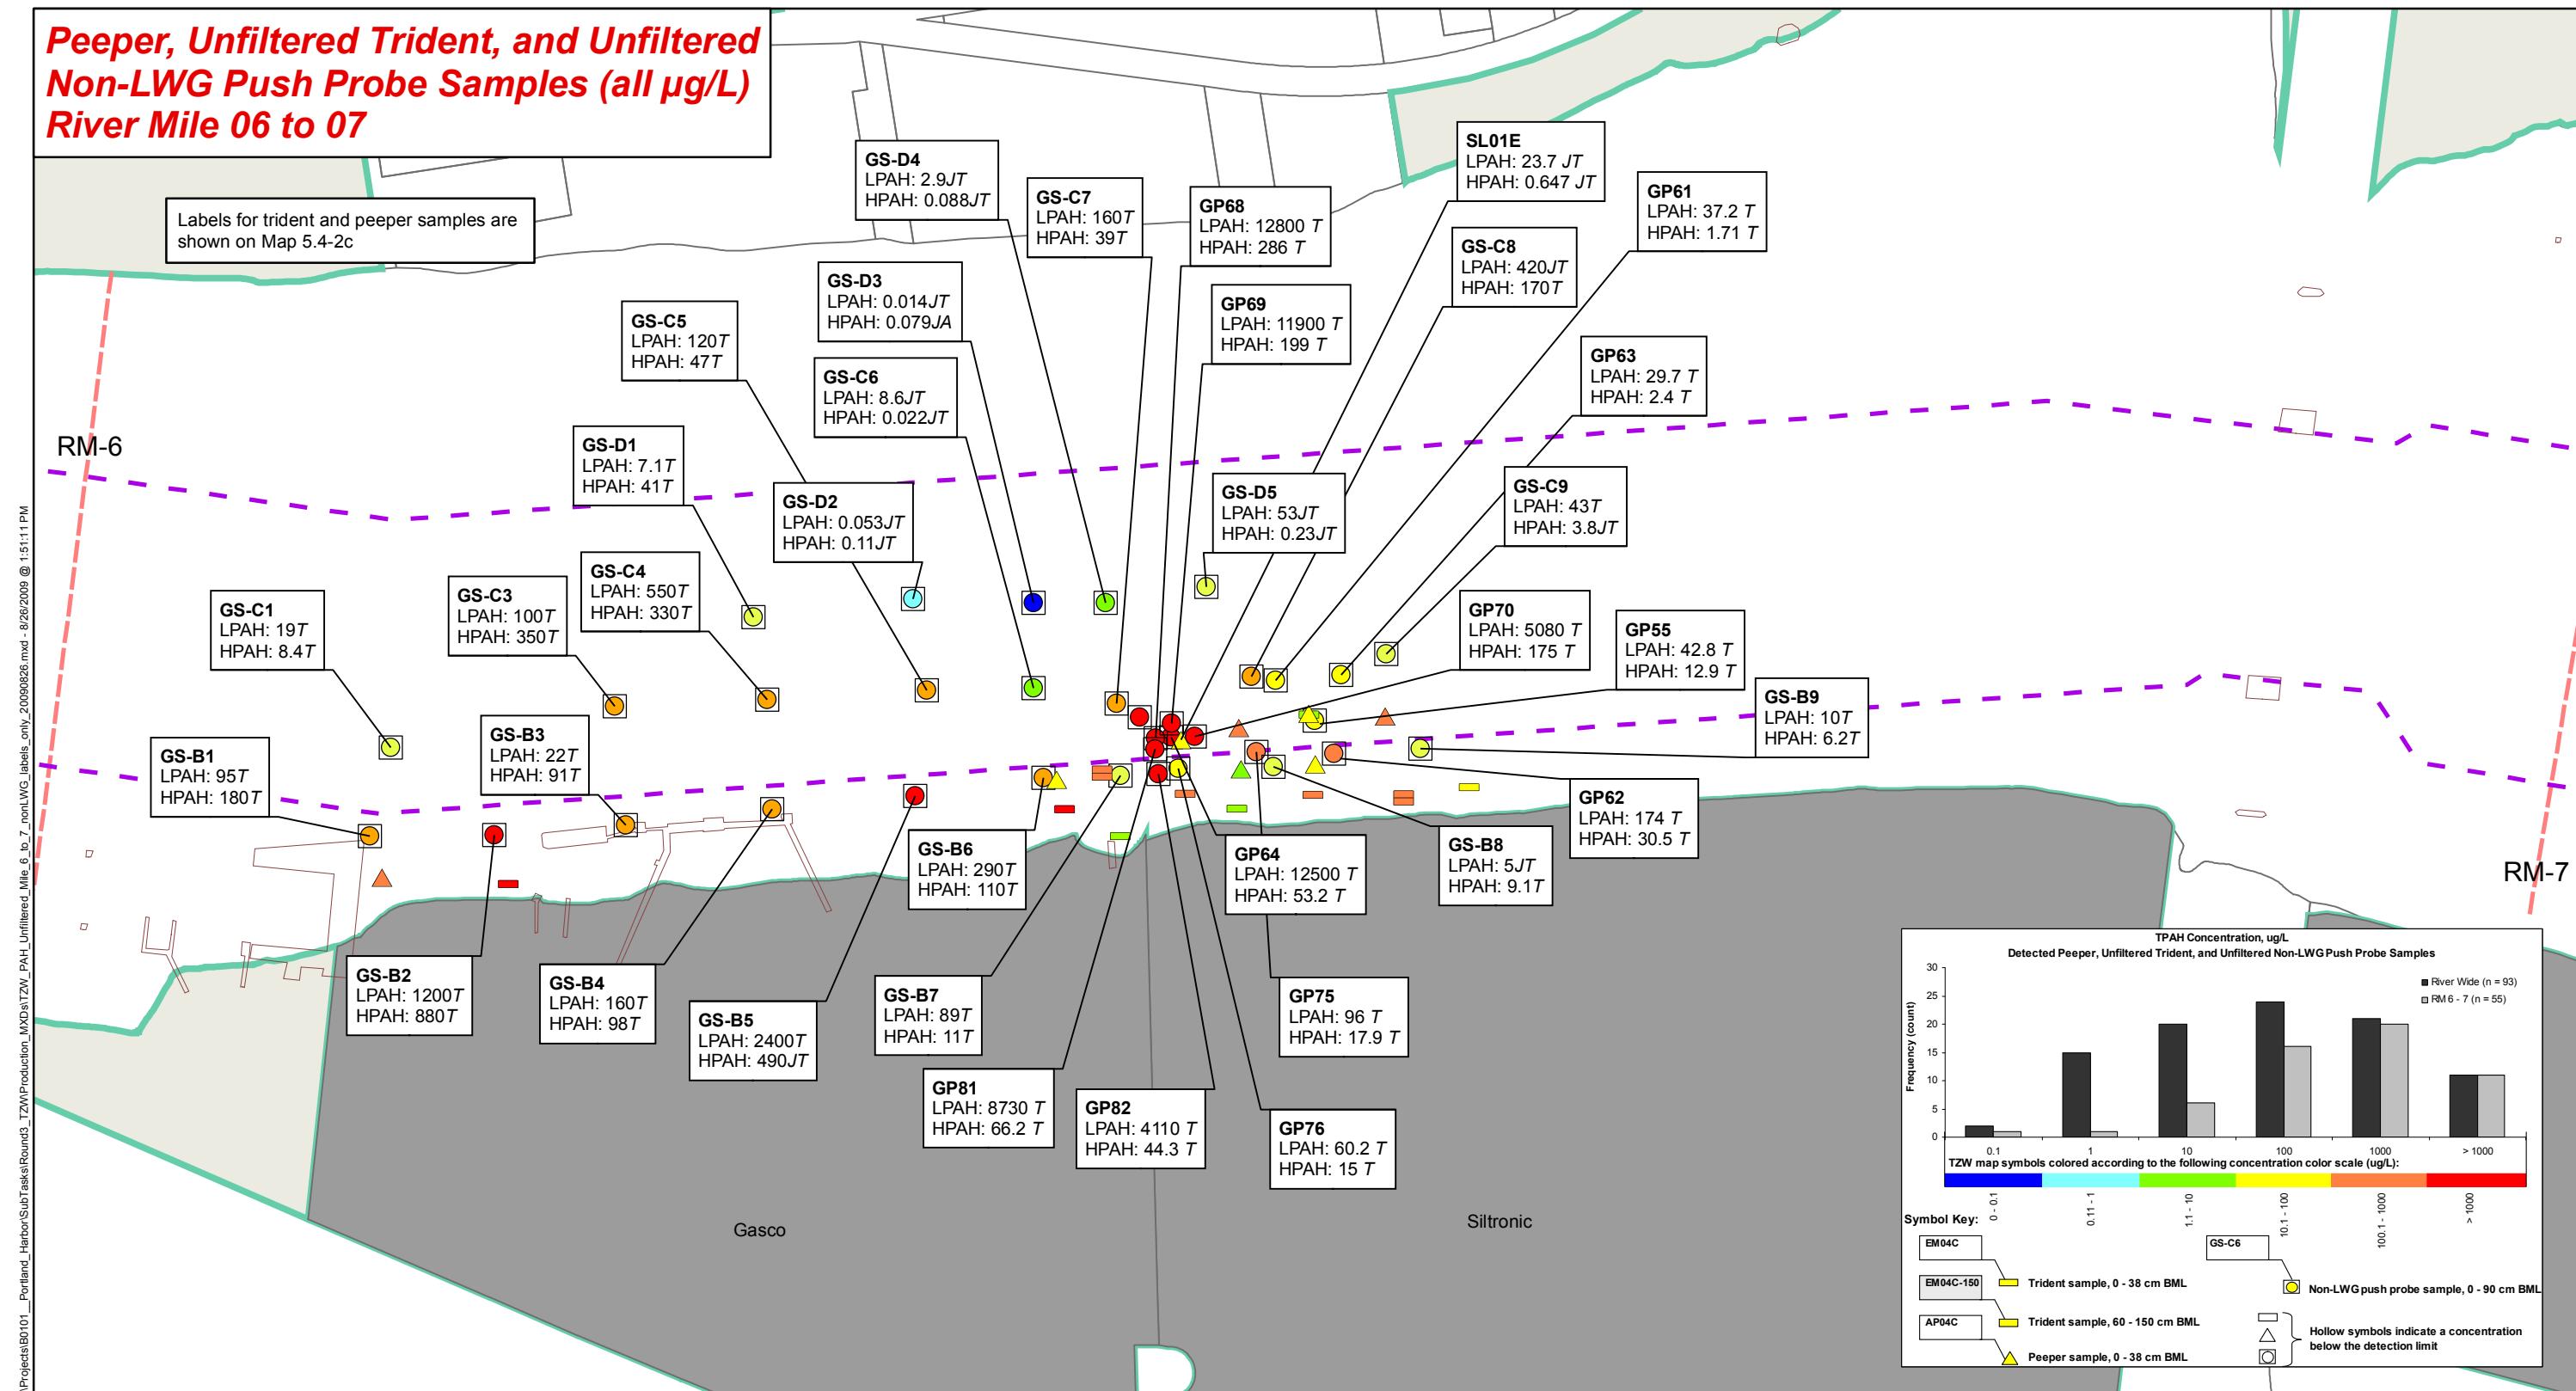
Map 5.5-2d
Portland Harbor RI/FS
Remedial Investigation Report
Transition Zone Water Chemistry
Total PAHs ($\mu\text{g/L}$)
River Mile 06 to 07, zoom

**Peeper, Unfiltered Trident, and Unfiltered Non-LWG Push Probe Samples (all $\mu\text{g/L}$)
River Mile 06 to 07**

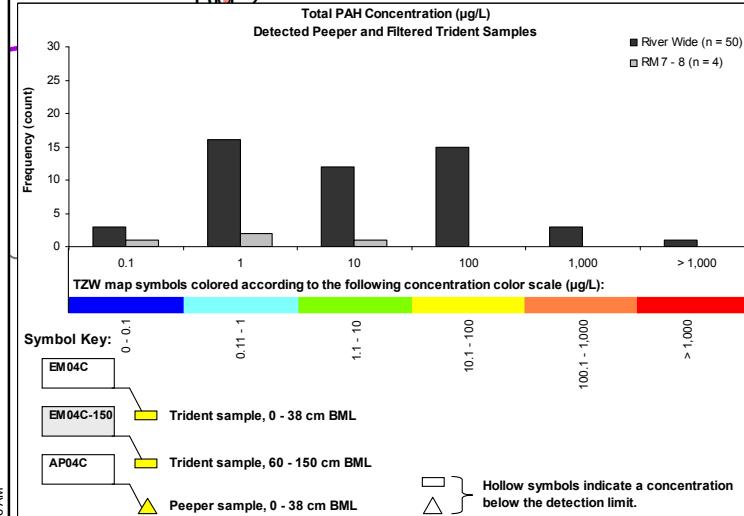
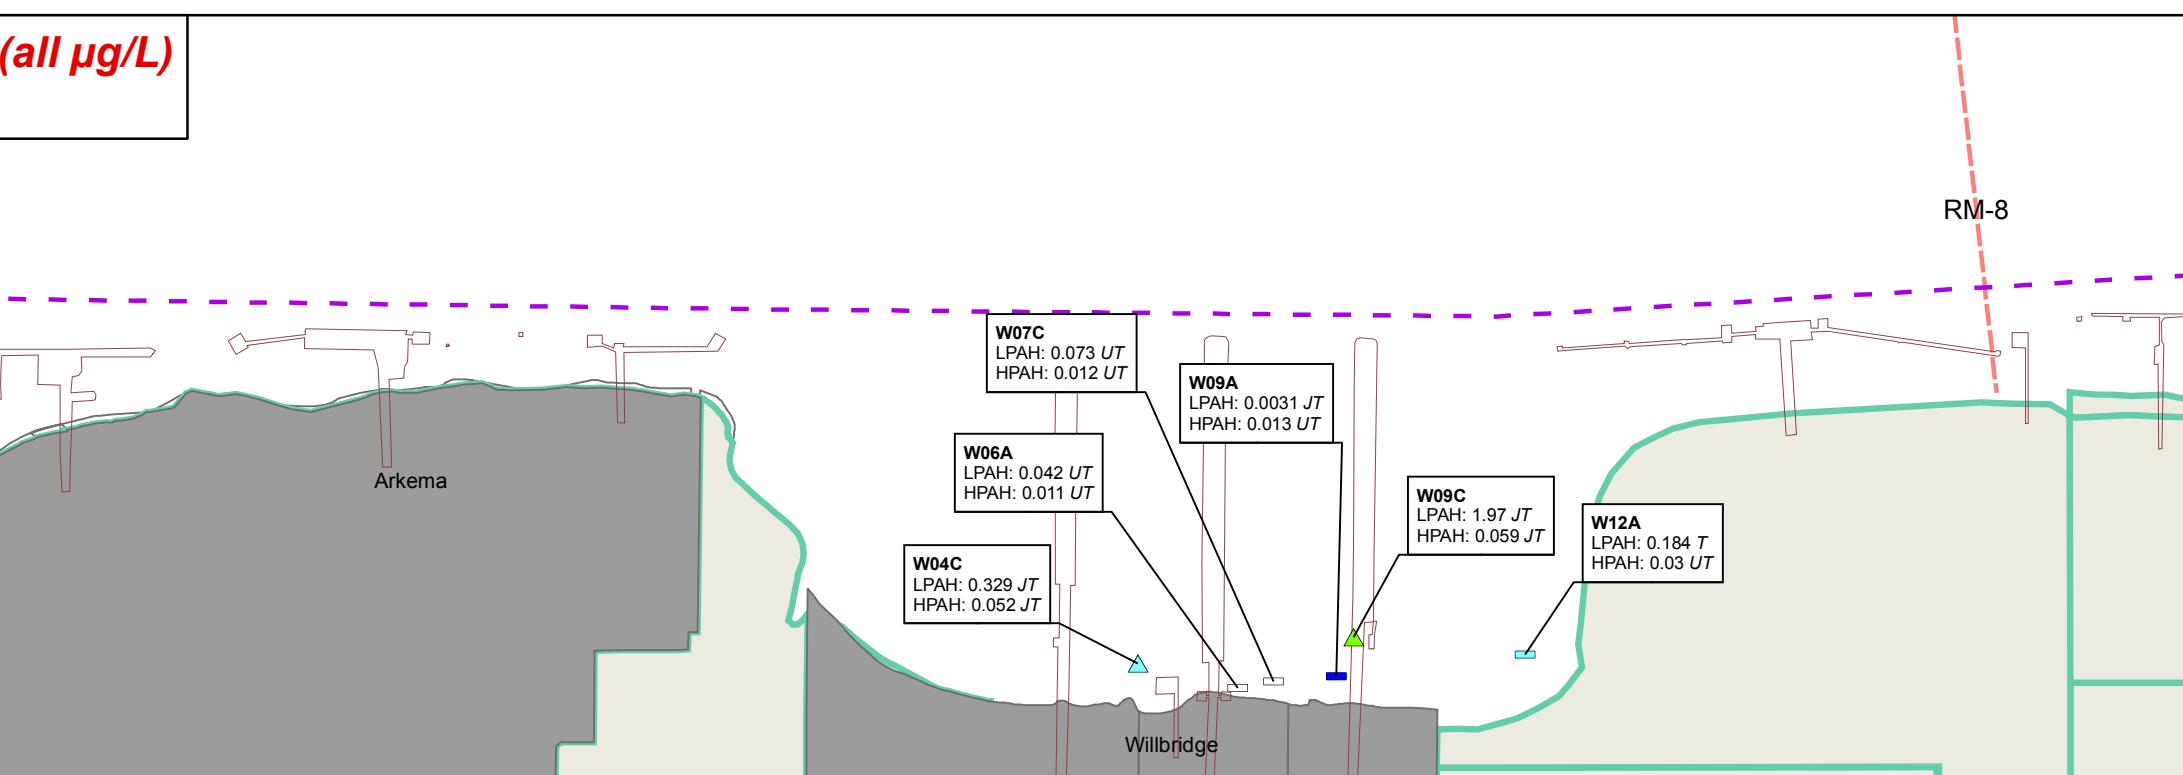
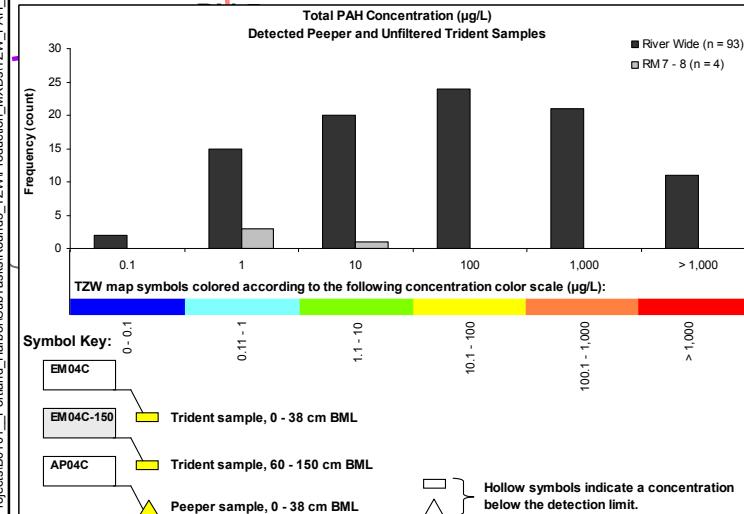
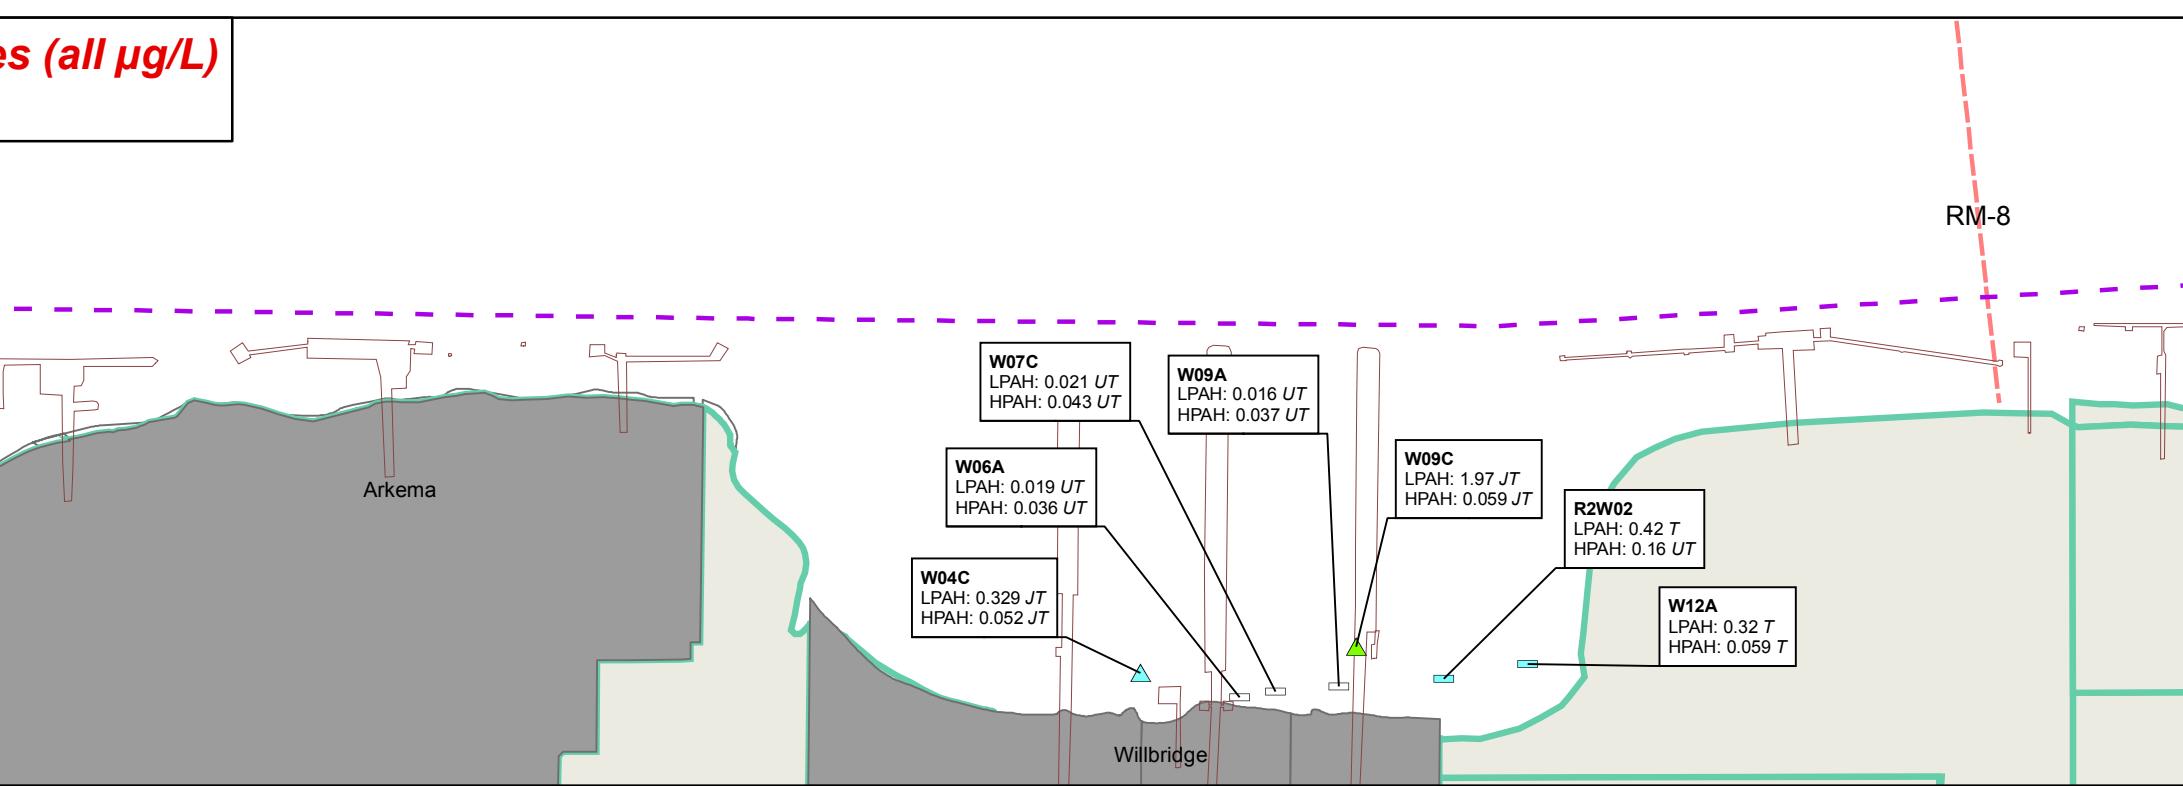
Peeper and Filtered Trident Samples (all µg/L)
River Mile 07 to 08

Peeper and Unfiltered Trident Samples (all µg/L)
River Mile 07 to 08

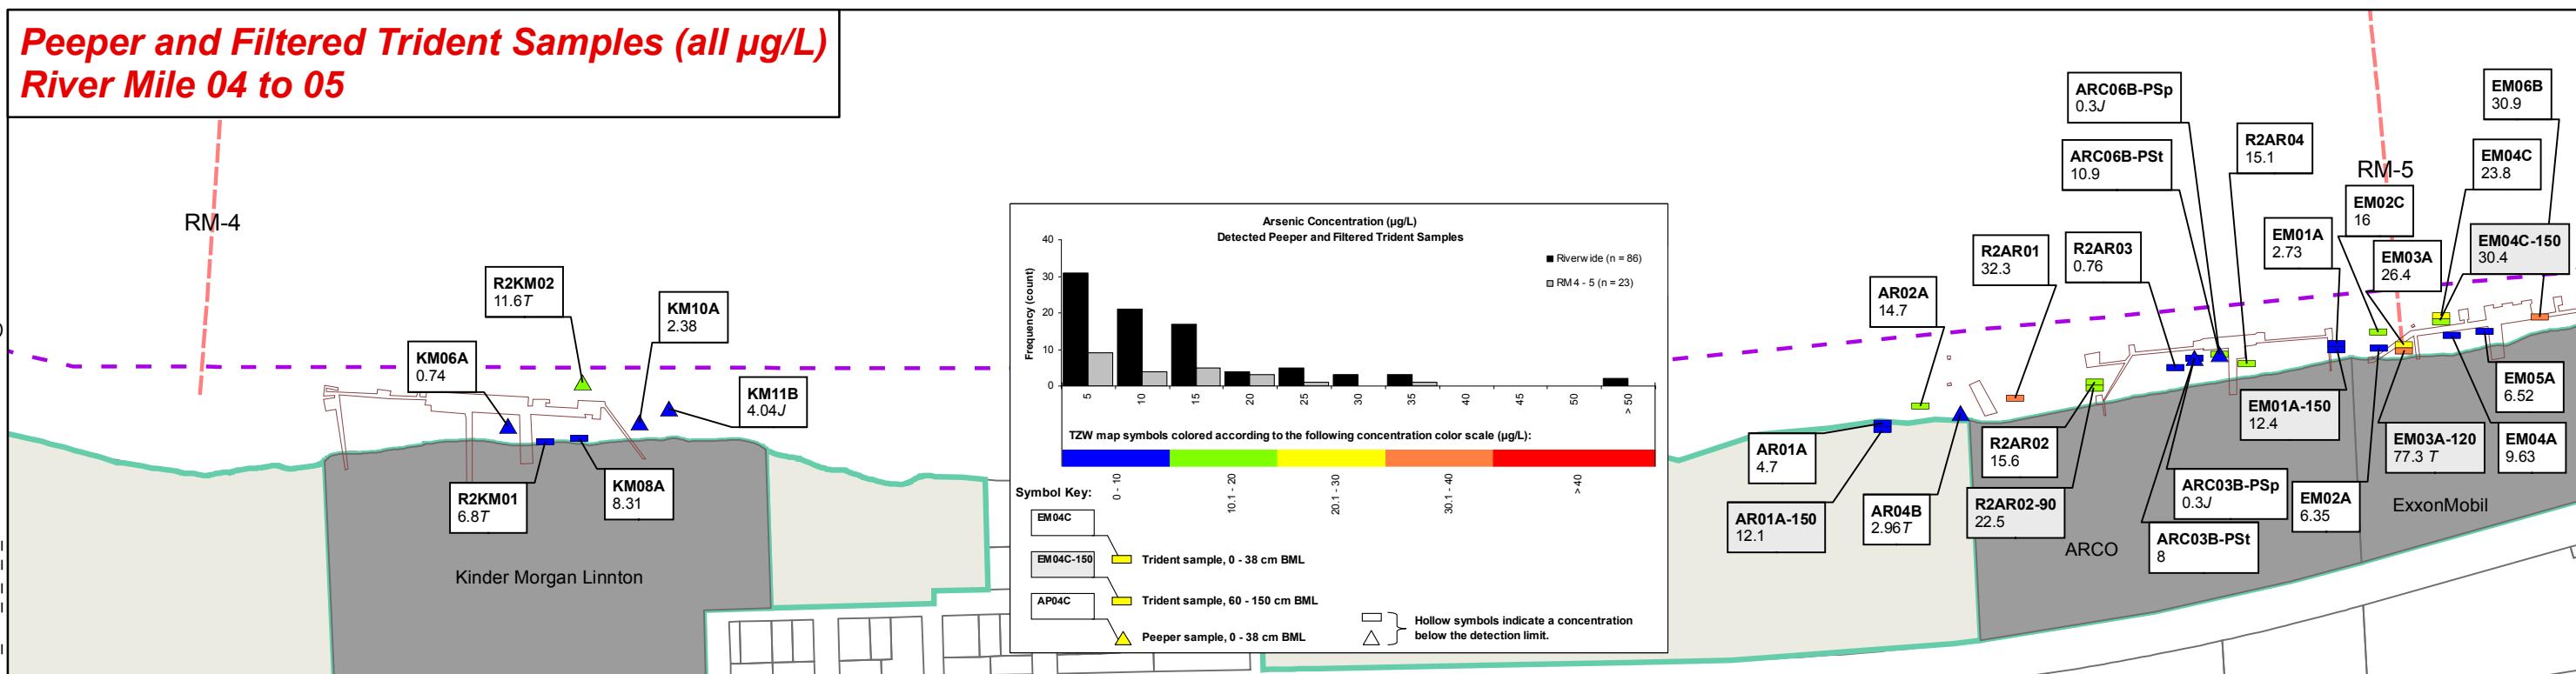
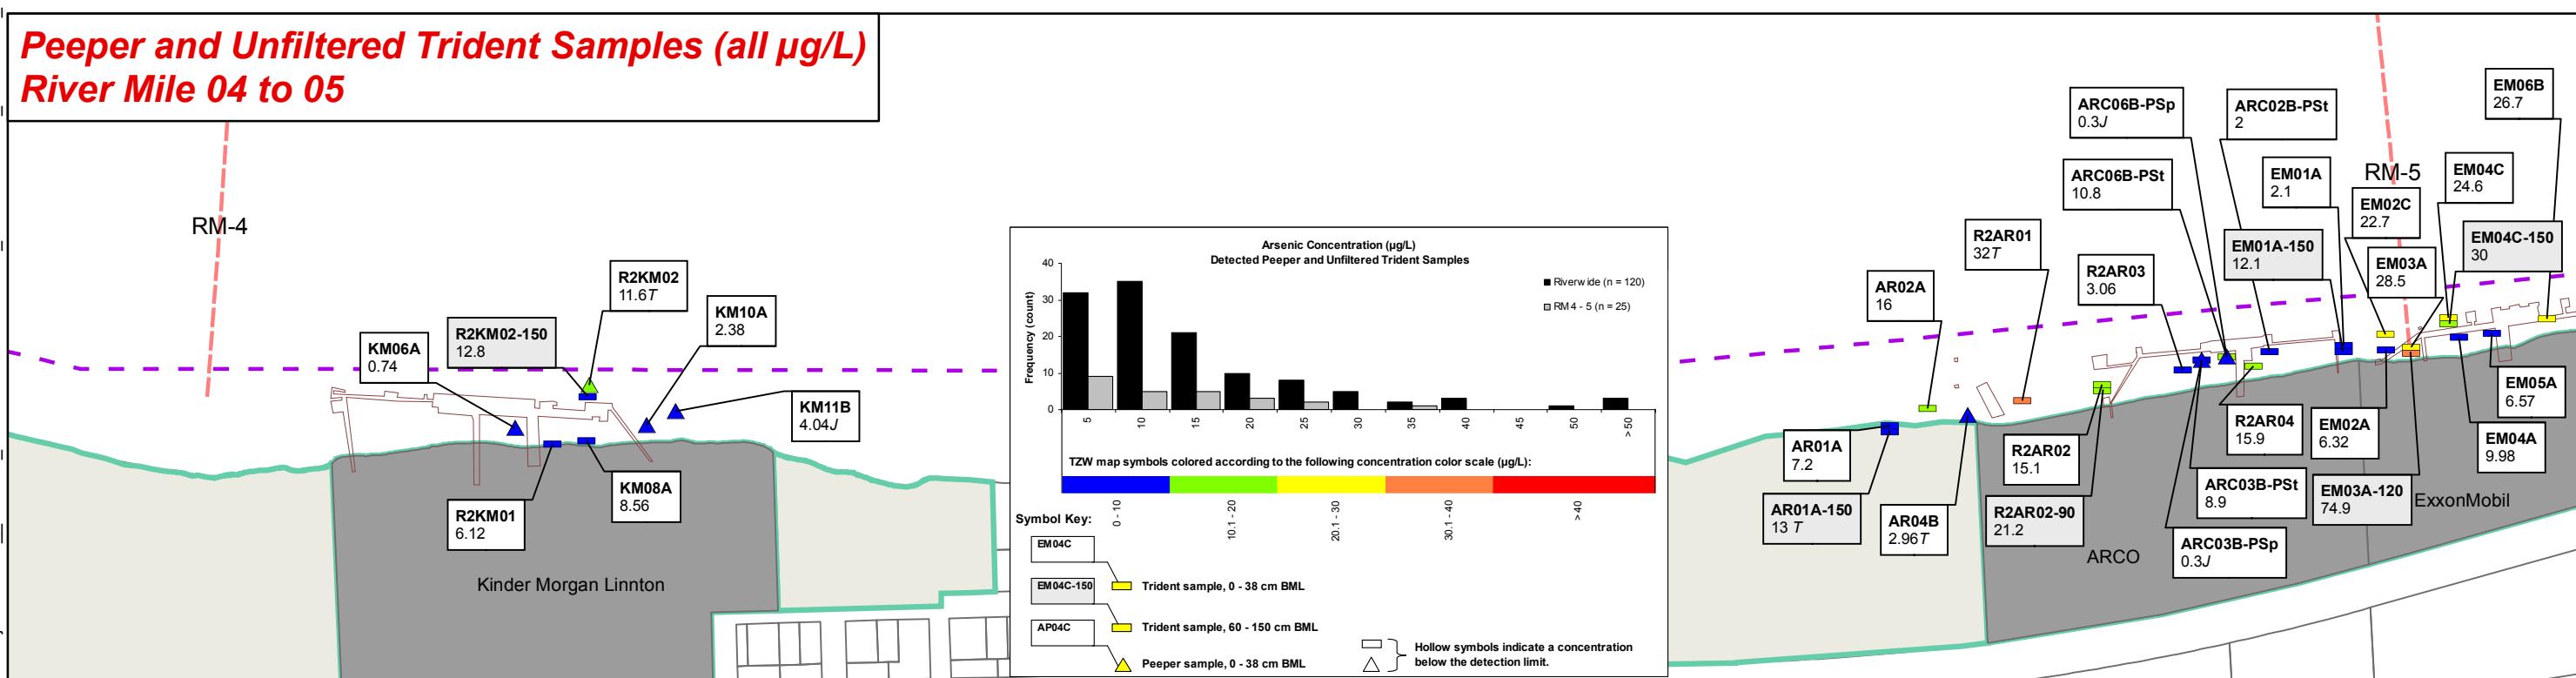
Map 5.5-3a

Pepper and Filtered Trident Samples (all µg/L)
River Mile 04 to 05

Pepper and Unfiltered Trident Samples (all µg/L)
River Mile 04 to 05

Portland Harbor RI/FS
Remedial Investigation Report
Transition Zone Water Chemistry
Arsenic (µg/L)
River Mile 04 to 05

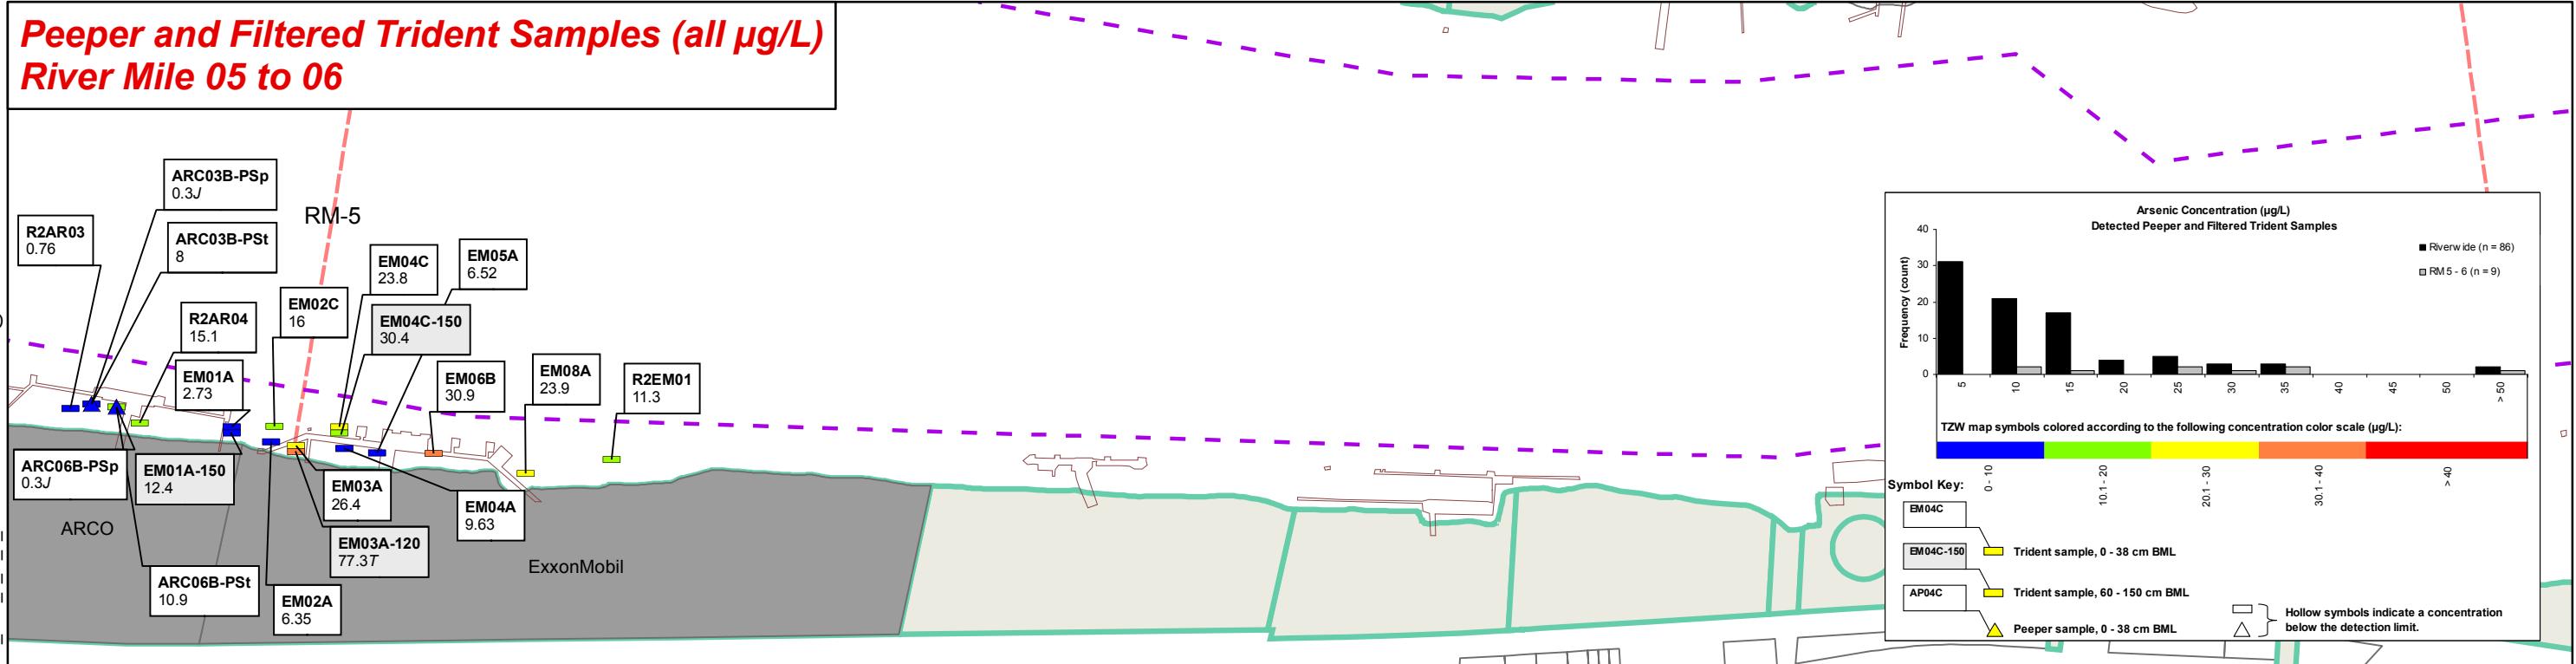
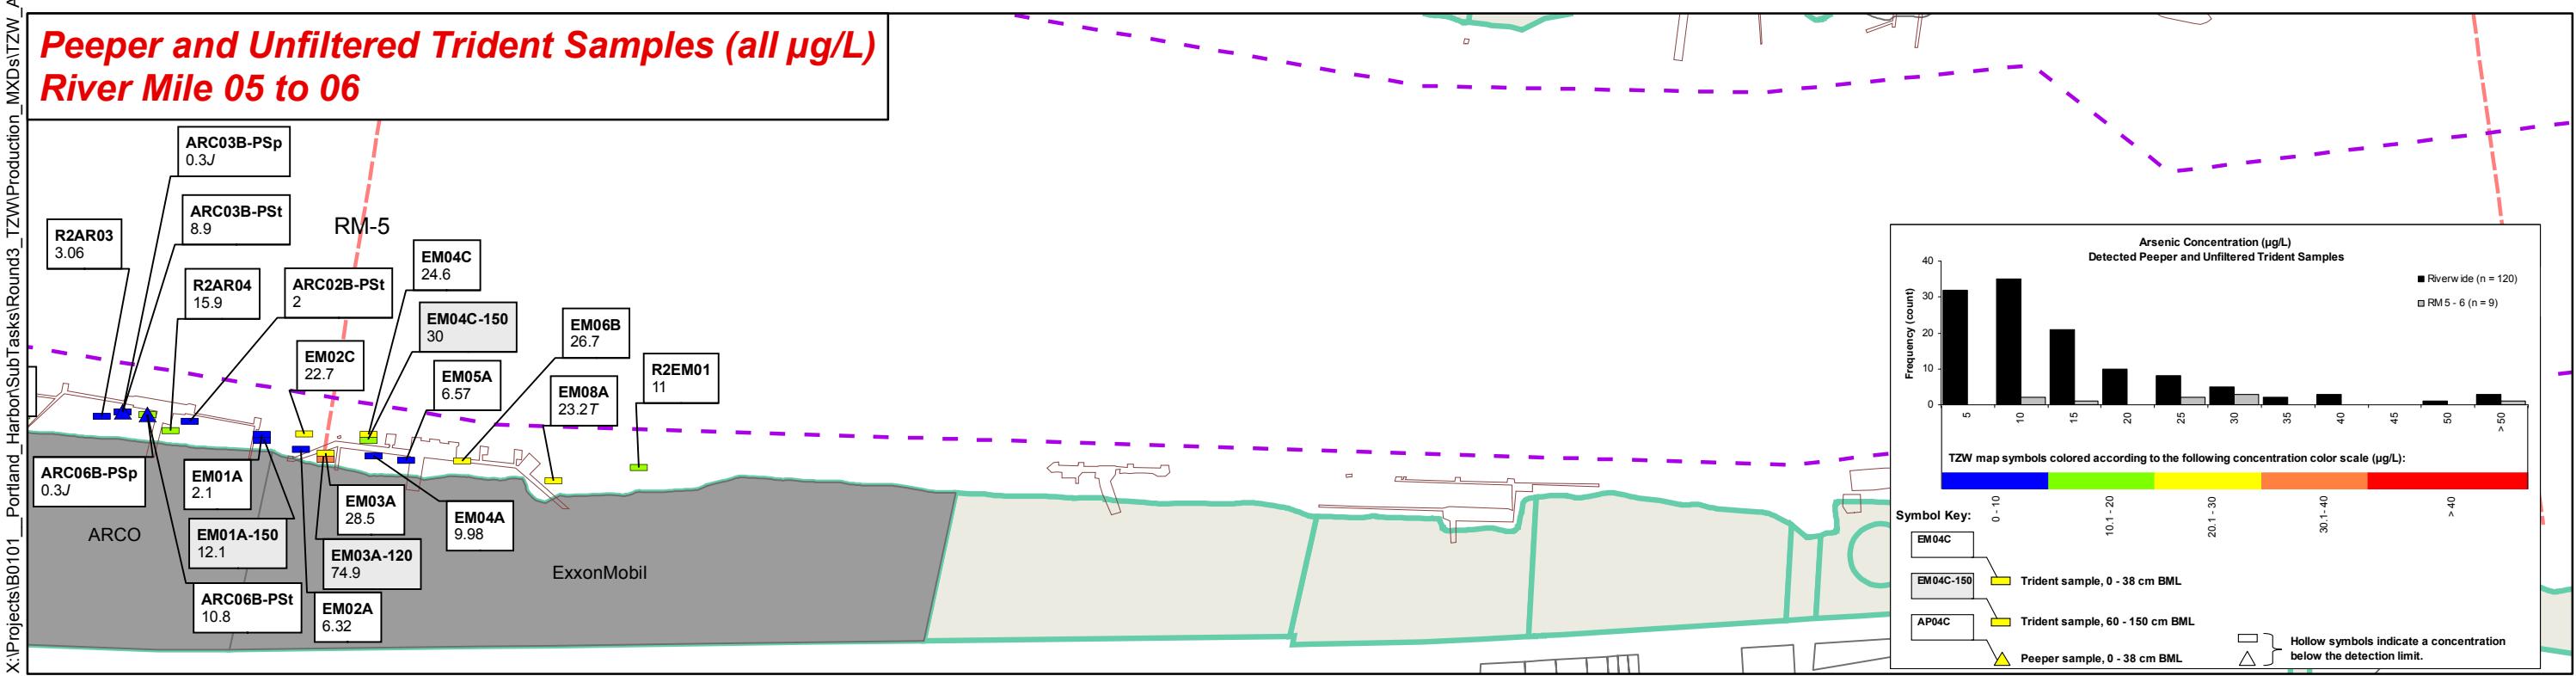
Map 5.5-3b

Portland Harbor RI/FS
Remedial Investigation Report
Transition Zone Water Chemistry
Arsenic (µg/L)
River Mile 05 to 06
